**UNITED STATES ENVIRONMENTAL PROTECTION AGENCY
REGION 5**

SUBJECT: Site Visit Report, Gary Development Landfill, Gary, Indiana, June 14, 2011

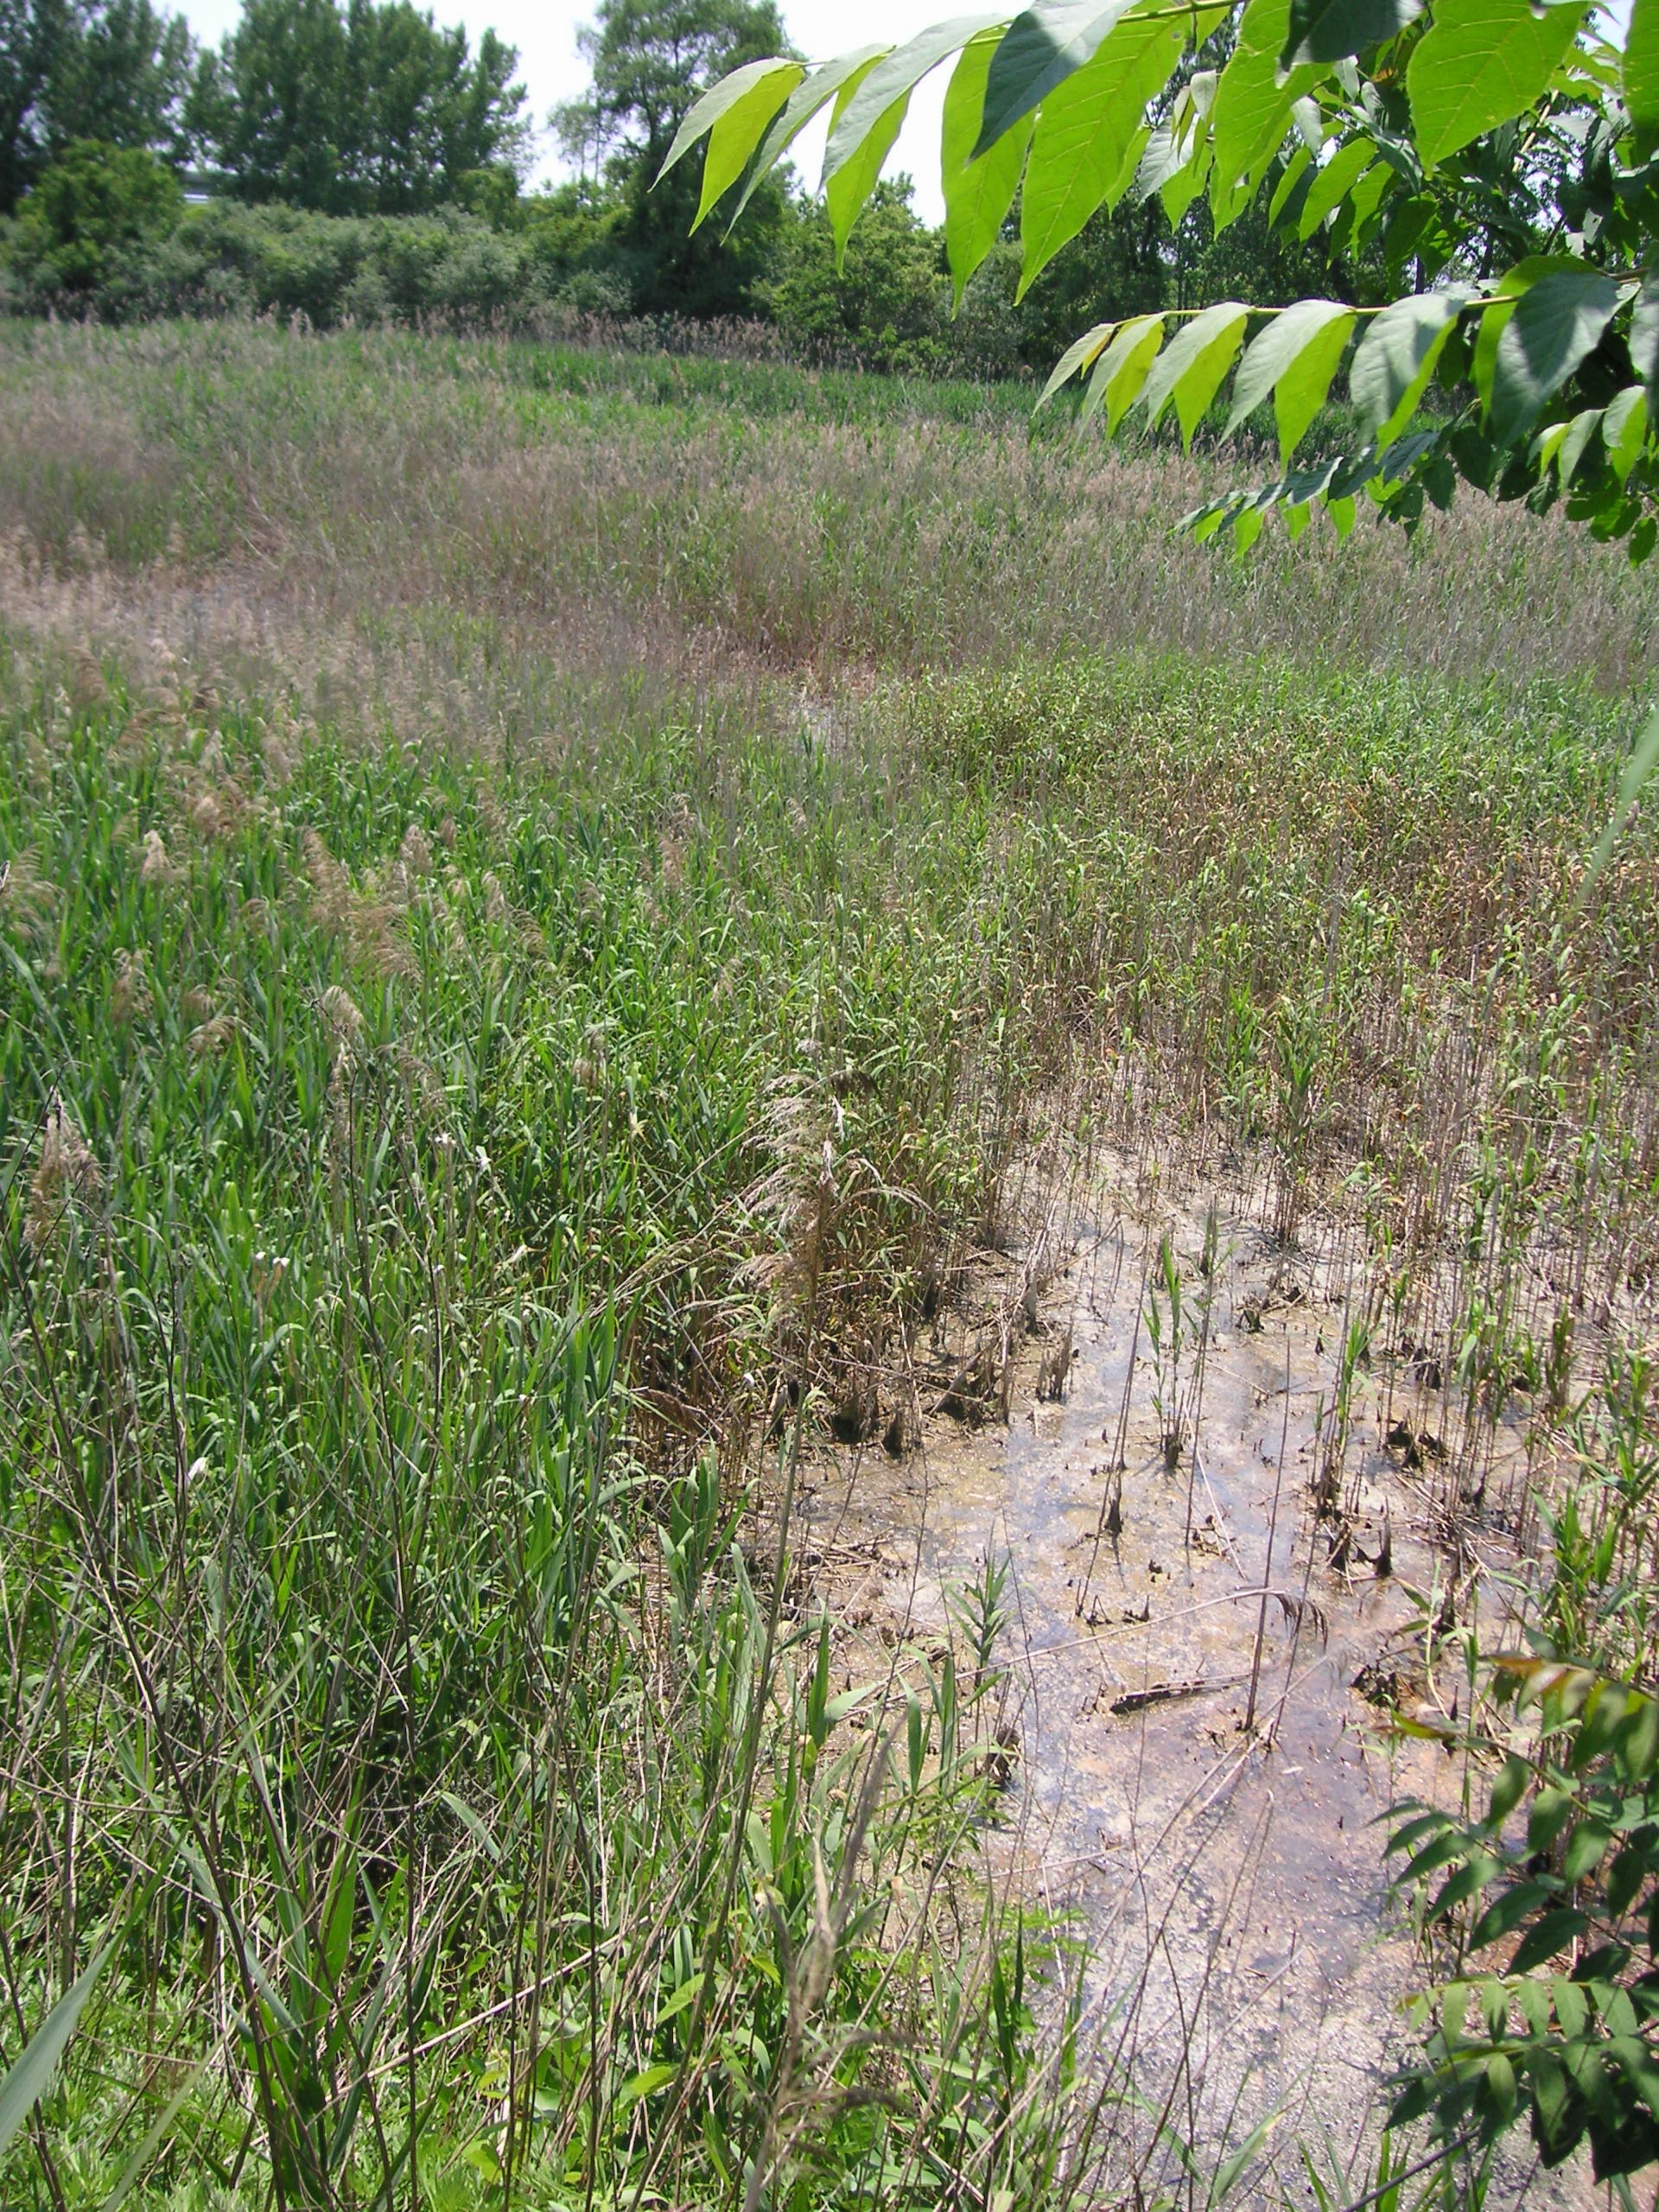
The landfill surface is uneven and covered with dense vegetation (Figure 1). Deer bedding sites were observed. Other observations were hindered by the thick vegetation.

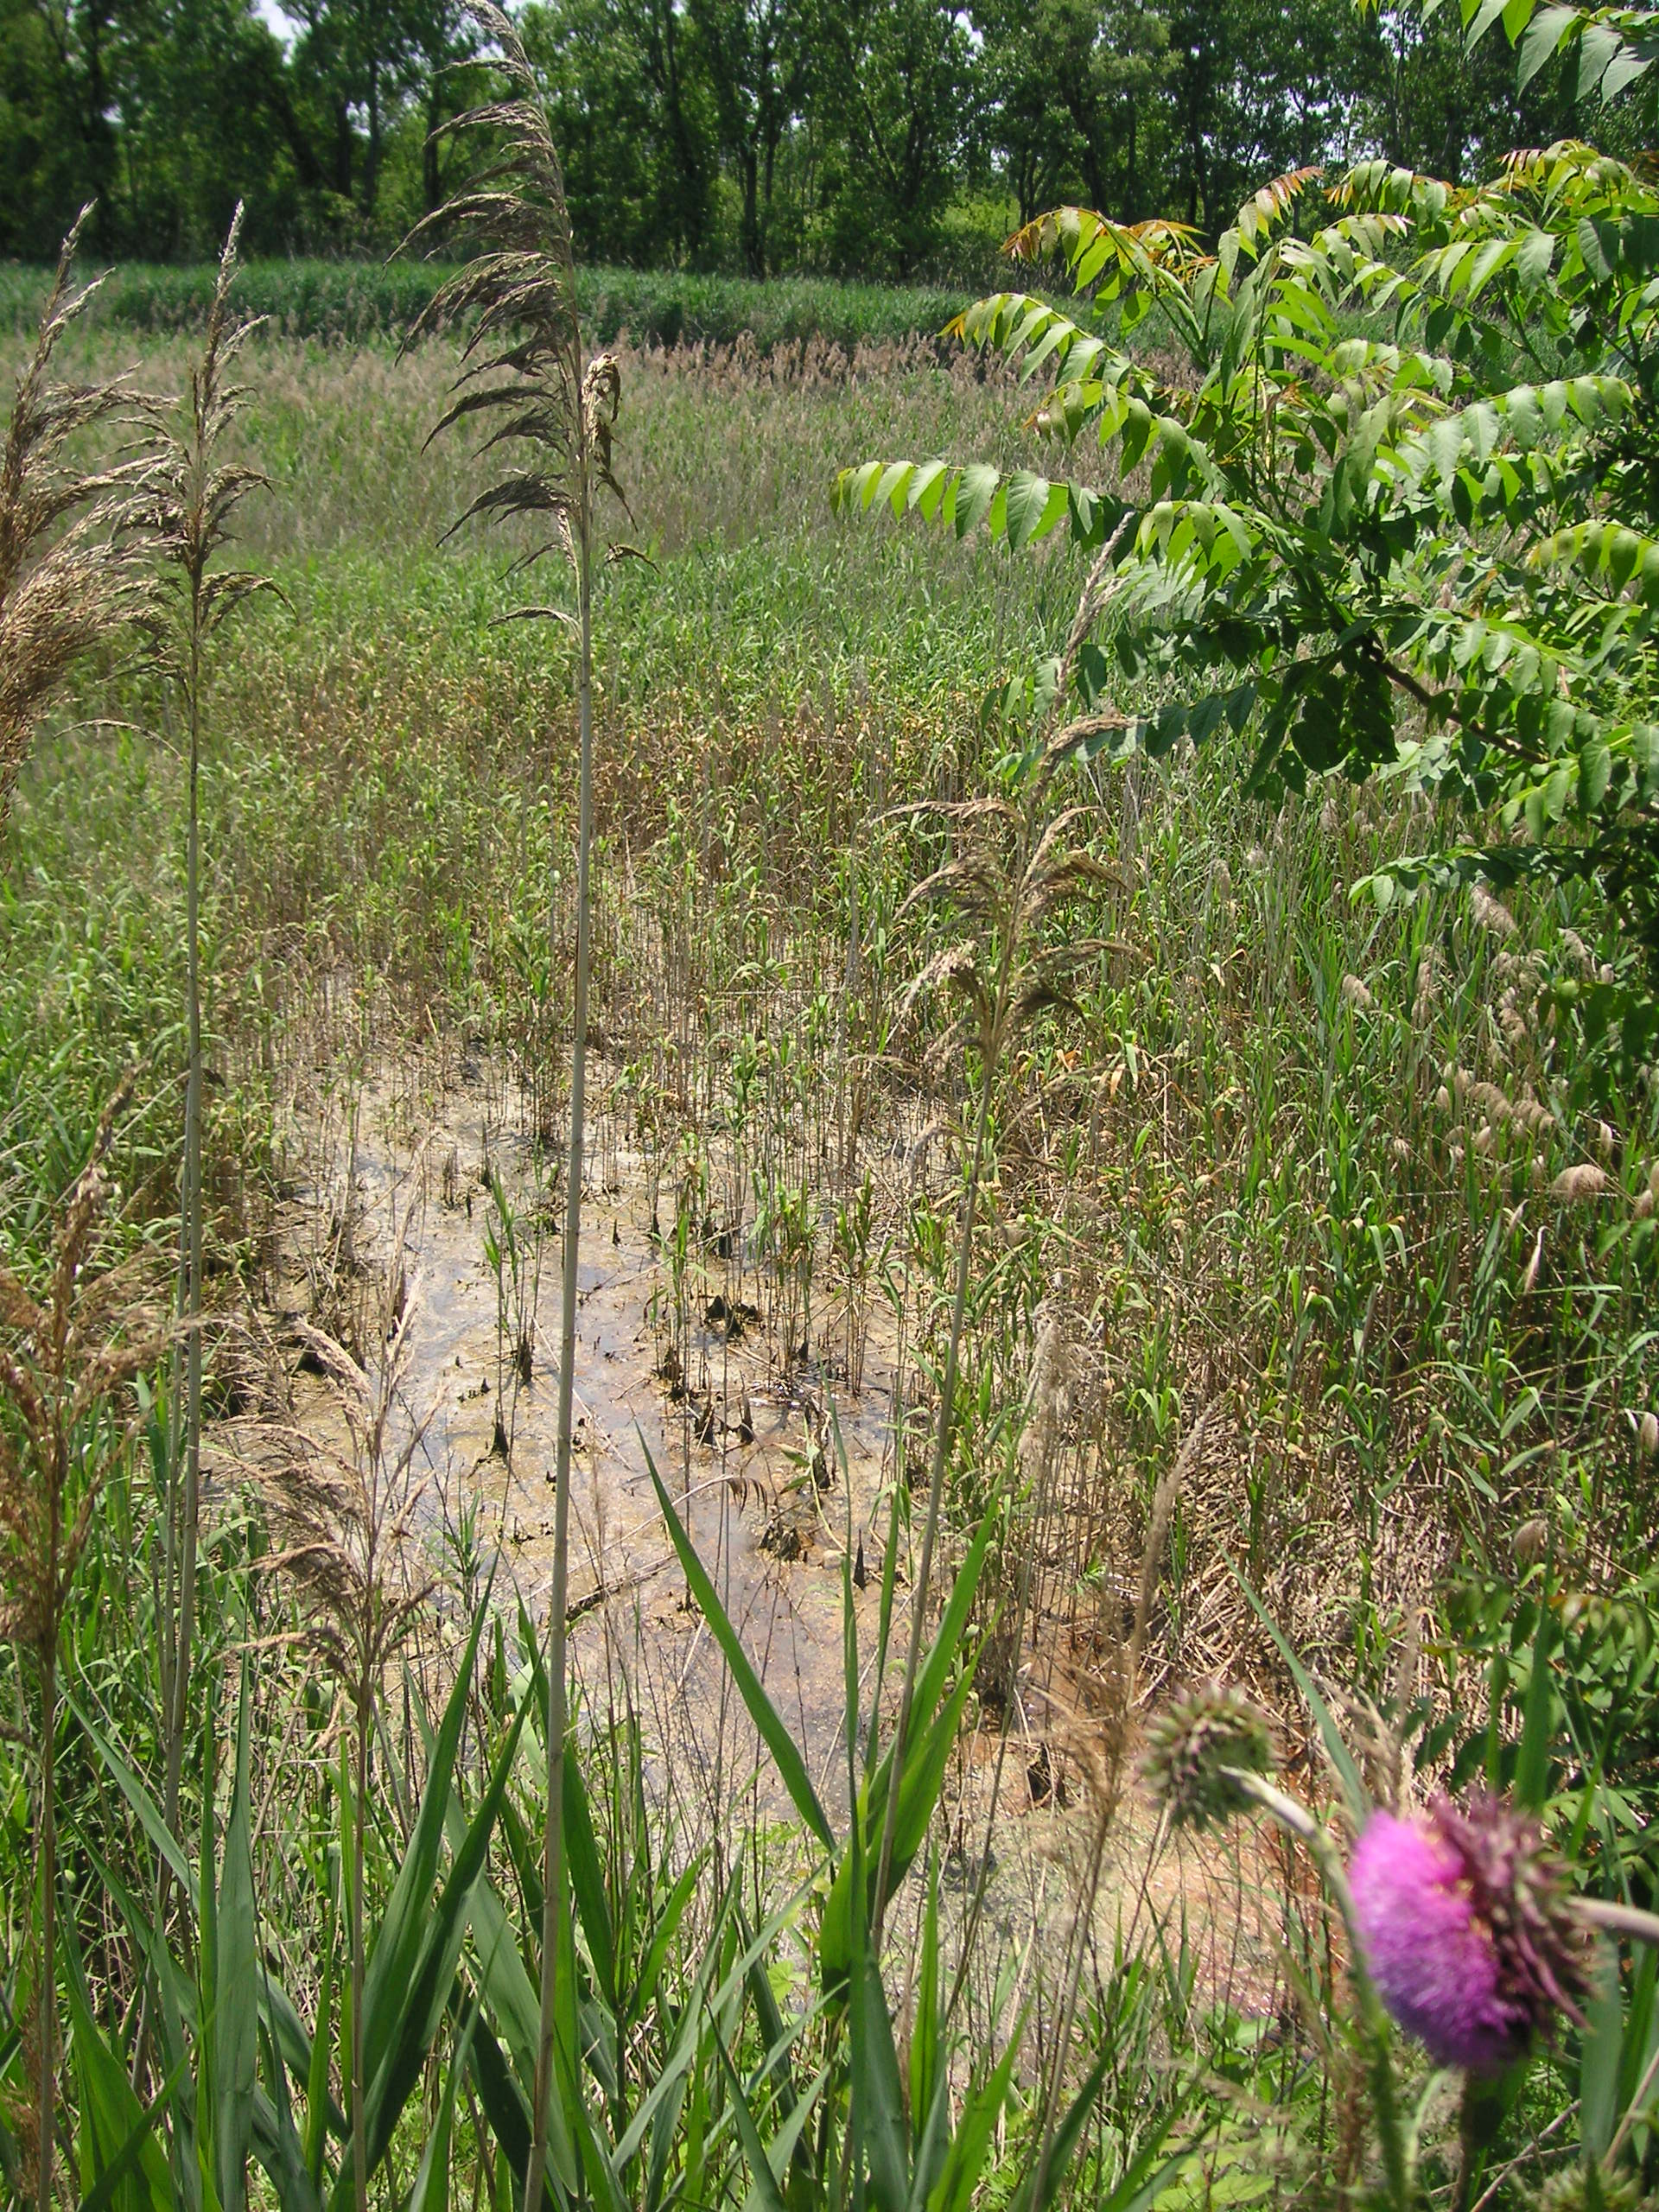
On our return to the vehicle, we observed booms deployed around the Vulcan Materials Corp. outfall with an oily sheen (Figure 5), upstream of the Gary Development Landfill.

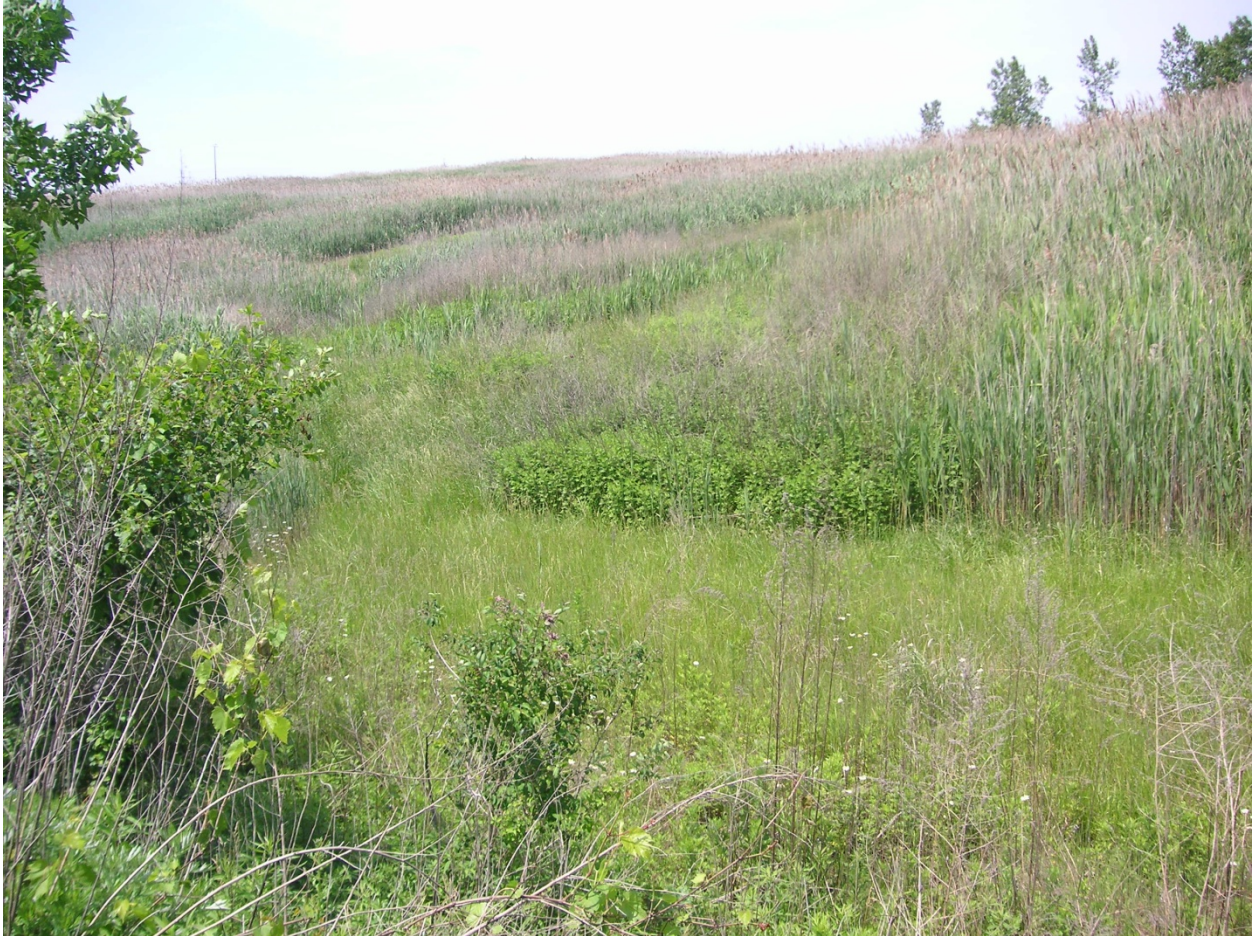
Figure 1. Southern side of the Gary Development Landfill, Gary, IN, 6/14/11, facing northwest.

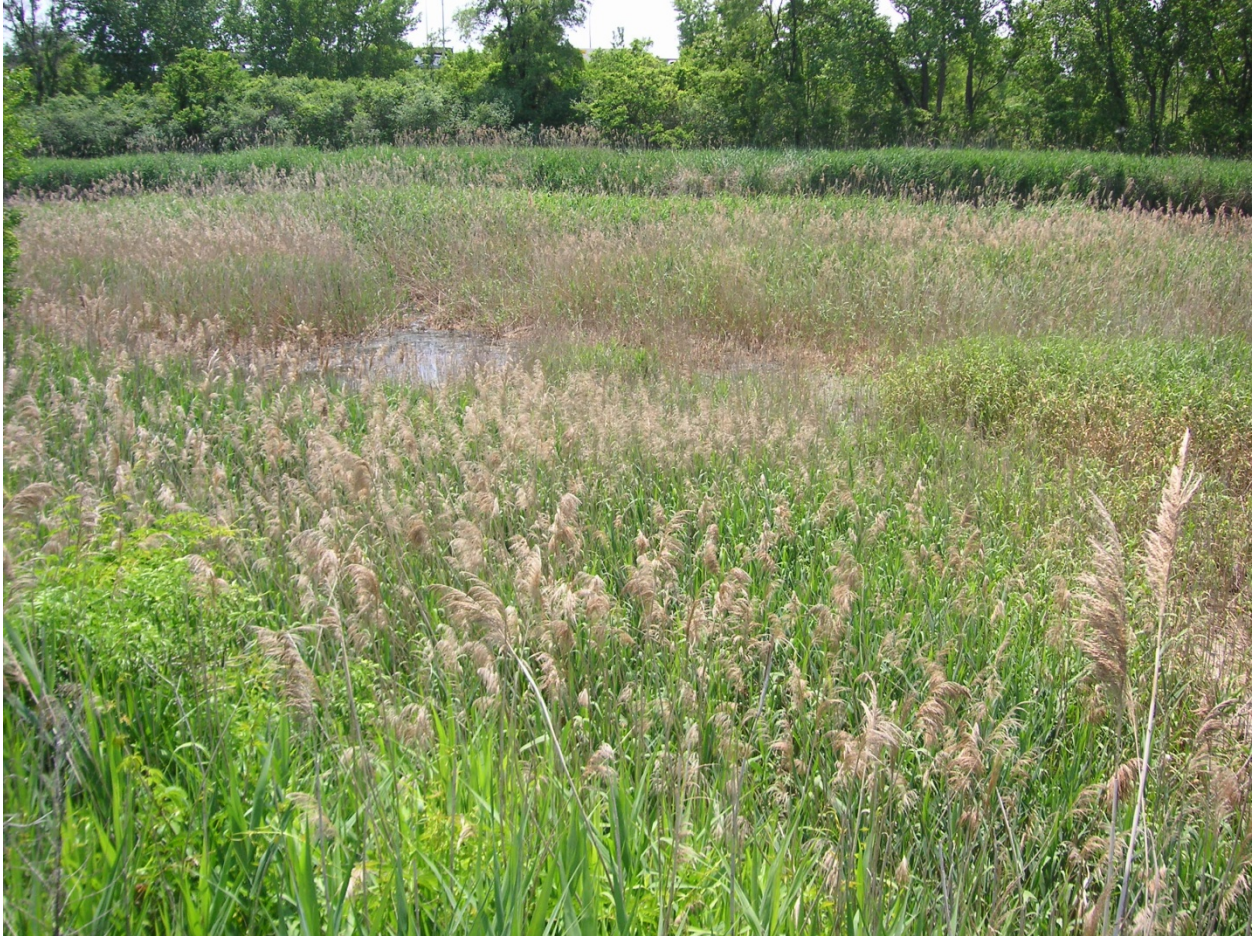
We walked part way into the wetland bordering the Grand Calumet River (Figure 2). The disturbed sediments where we stepped gave off a strong petroleum/solvent odor. We located the probable point of entry (PPE) of landfill discharge to the south wetland (Figure 3). The distinct orange coloration (Figure 4), probably iron oxides, is unlikely to be toxic but is an indication of discharge of anoxic leachate to the surface, which may contain other toxic substances.

Figure 2. South wetland, Gary Development Landfill, Gary, IN, 6/14/11, facing southeast. The trees and shrubs in the background are on the opposite bank of the Grand Calumet River.

Some thoughts on data gaps are as follows. The spatial pattern of contamination in the wetland is not clear. I recommend sampling in a grid pattern in the wetland to determine extent and to differentiate contaminants released from landfill discharge from ones deposited from the river (upstream sources).

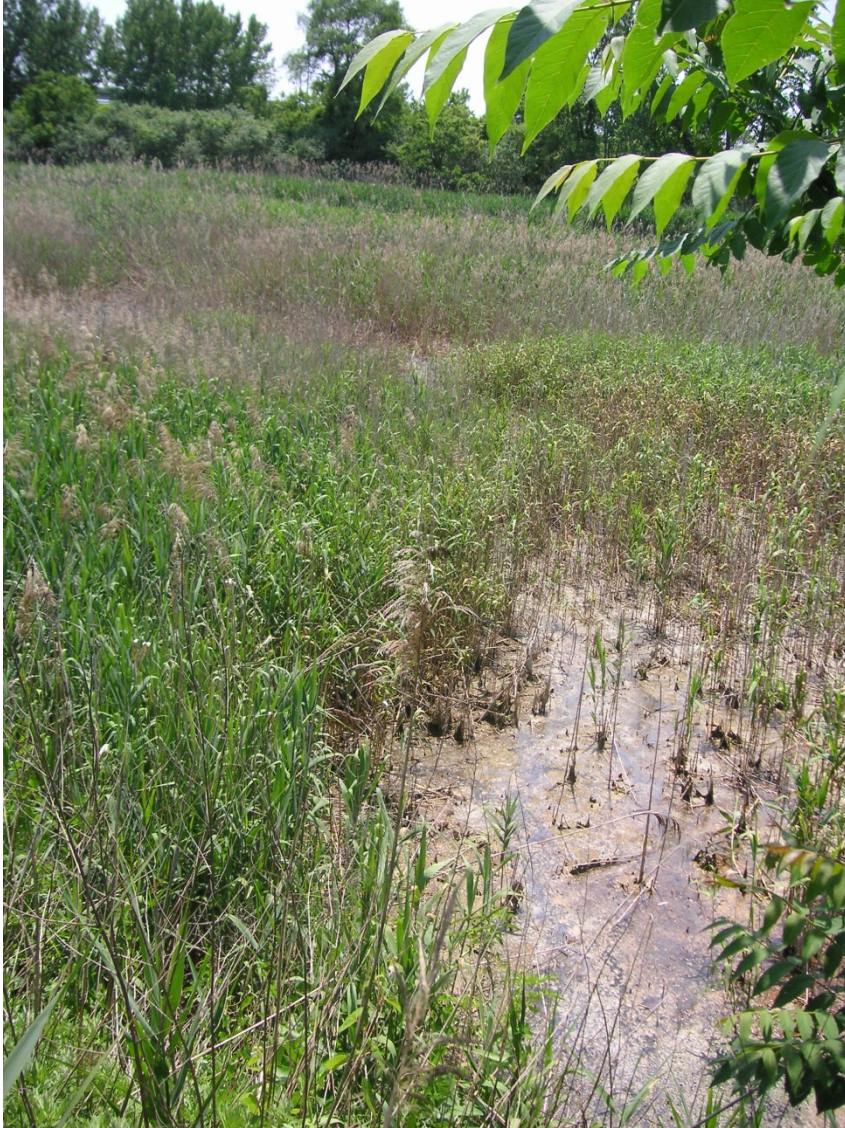
Figure 3. Probable Point of Entry (PPE) of landfill discharge to the wetland, Gary Development Landfill, Gary, IN, 6/14/11, facing south.

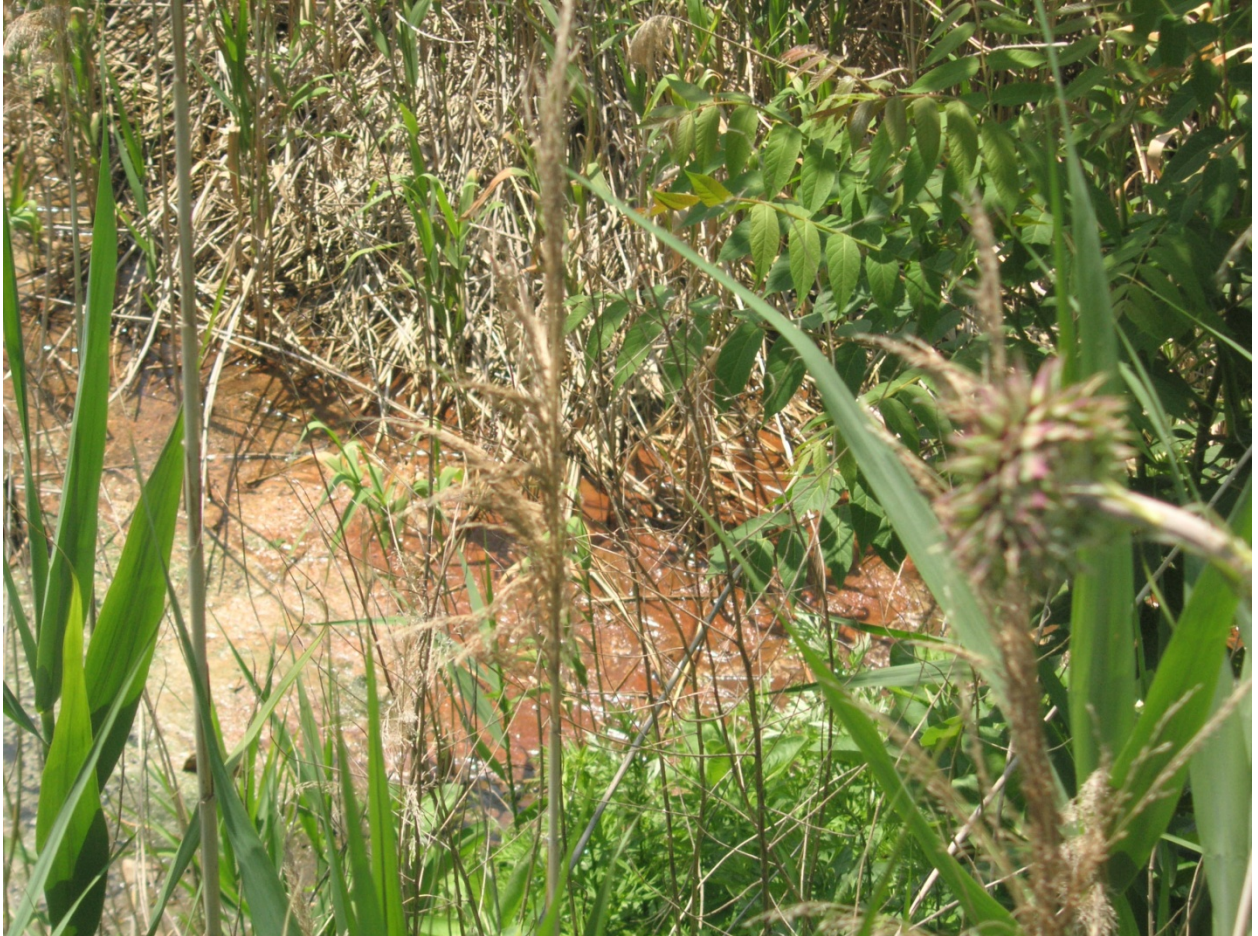
Figure 4. Close-up of the Probable Point of Entry (PPE) of landfill discharge to the wetland showing orange coloration, Gary Development Landfill, Gary, IN, 6/14/11, facing south.

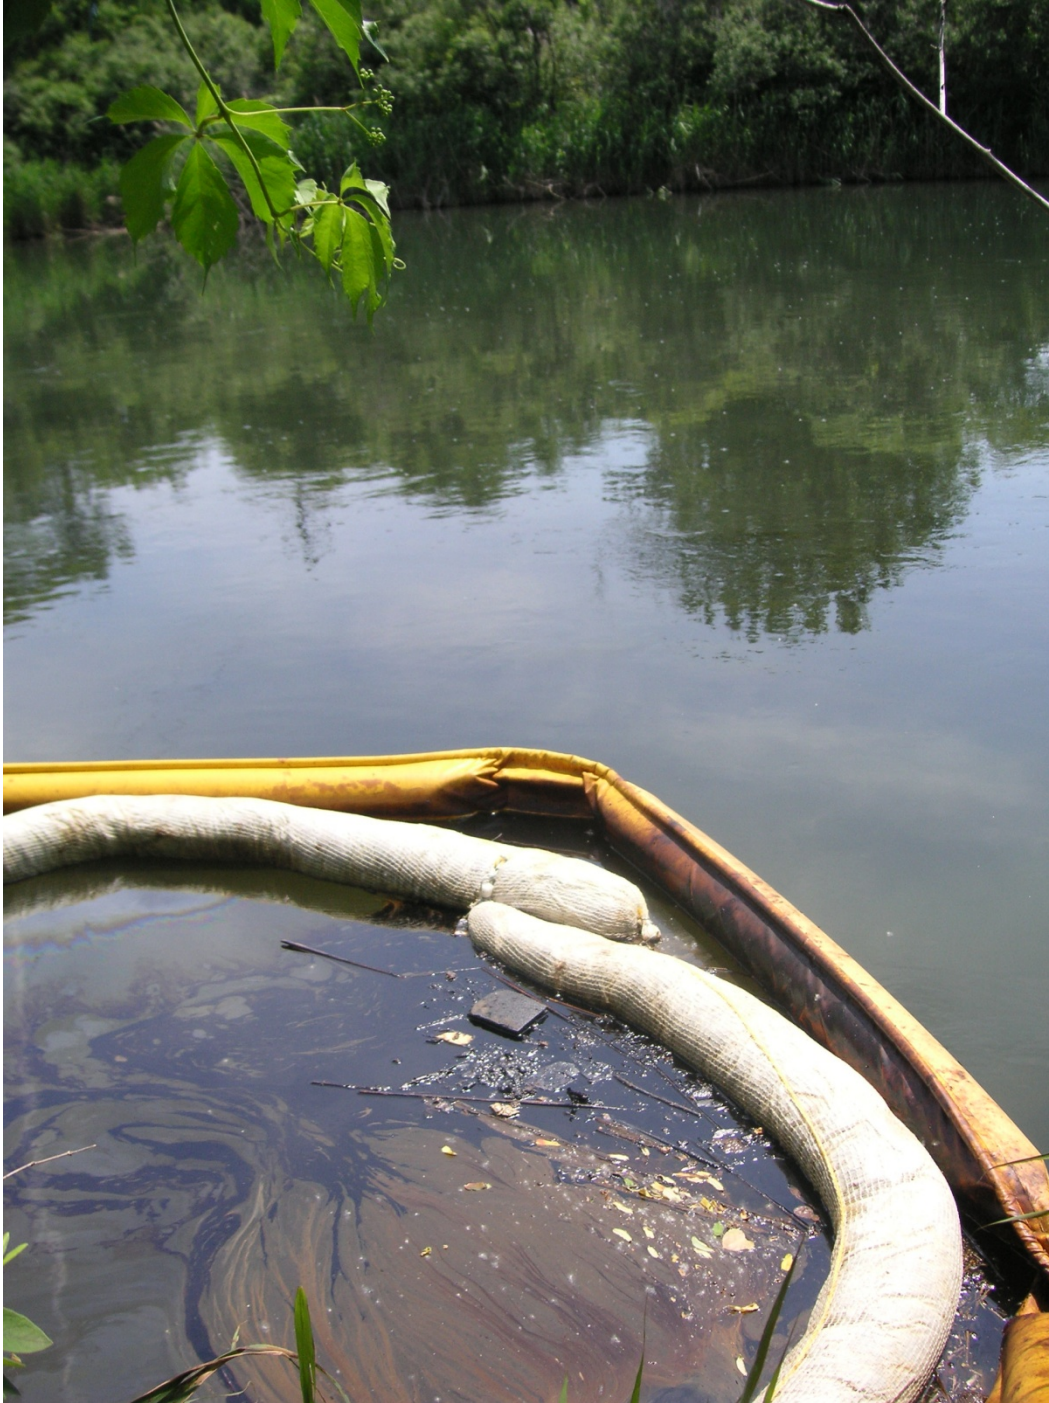
Figure 5. Boom and sheen, Vulcan Materials Company outfall on the Grand Calumet River, upstream of Gary Development Landfill, Gary, IN, 6/14/11, facing south.
